**Flood Control Project Maintenance
Levee Inspections**
LMA District Cover Sheet
Spring 2010 Levee Inspection Results

City of Sacramento

Spring 2010 Levee Inspection Results

Levee Inspection Report By Mile - Spring 2010

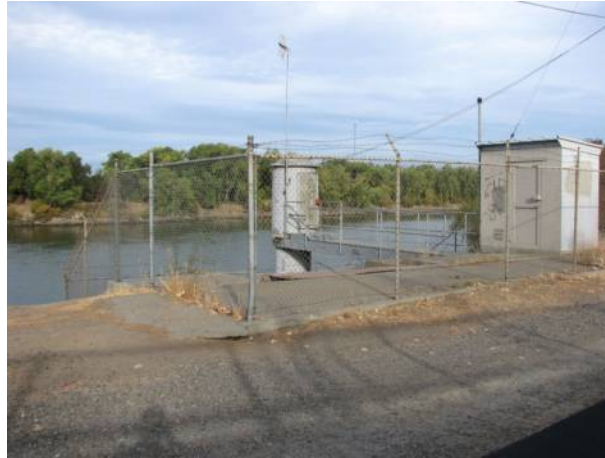
| Levee Mile Report Line | 1 |

| Waterway | | | | | | | Bank | Unit Miles | Inspection Start/End | | Inspector |
|---|---|---|---|---|---|---|--|---|---|---|---|
| 1 | 0.14 | 0.14 | Earthen Levee | Encroachments | WS | PO | Buildings Inspector Comments: state recorder can(DWR) fenced area | 38.588715 ° -121.504885 ° | 38.588715 ° -121.504885 ° | 1 Y | |

Recorder can (DWR)

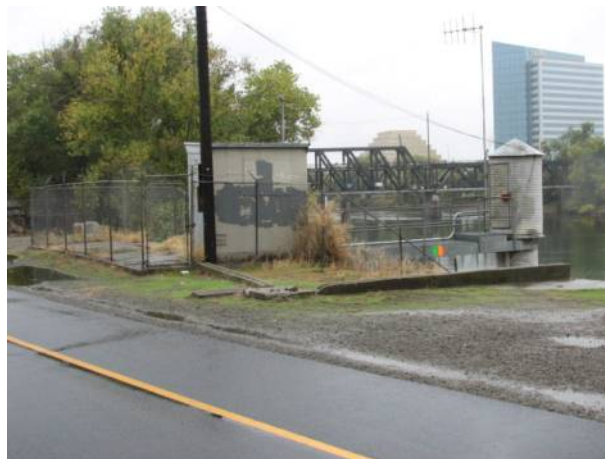
| Levee Mile Report Line | 1 |

I Street recorder can

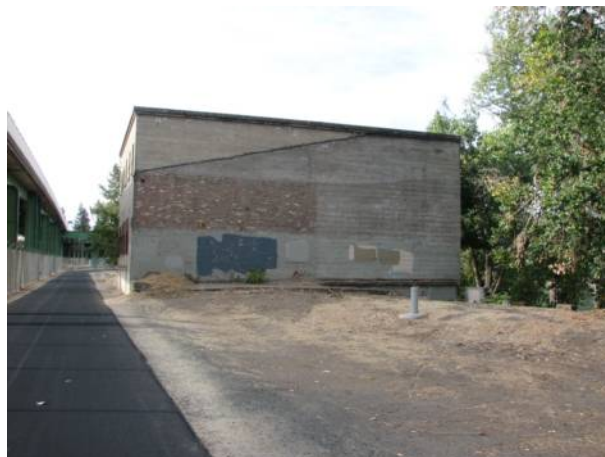
| Levee Mile Report Line | 2 |

| Waterway | | | | | | | Bank | Unit Miles | Inspection Start/End | | Inspector |
|---|---|---|---|---|---|---|--|---|---|---|---|
| 2 | 0.16 | 0.16 | Earthen Levee | Encroachments | WS | PO | Buildings Inspector Comments: historical building | 38.588425 ° -121.504860 ° | 38.588425 ° -121.504860 ° | 2 Y | |

Historical Building : State Parks & Recreations

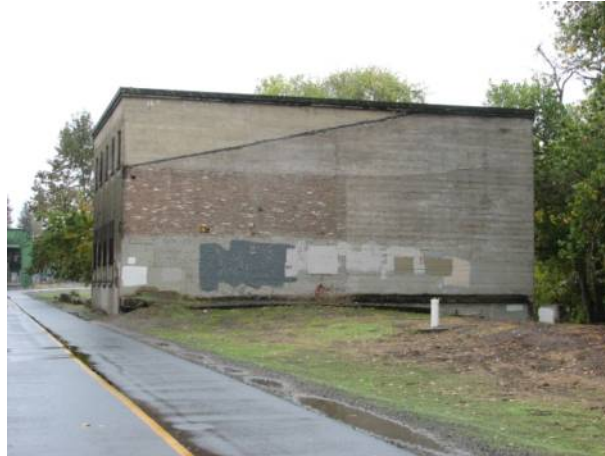
| Levee Mile Report Line | 2 |

| Historical Building with foundations and Ramps on upstream and downstream sides | |

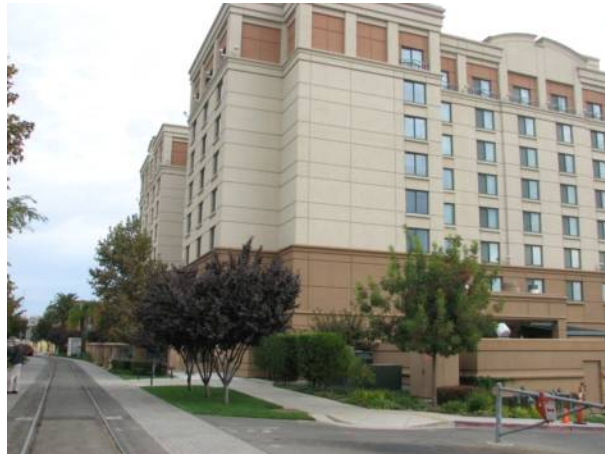
| Levee Mile Report Line | 4 |

| Waterway | | | | | | | Bank | Unit Miles | Inspection Start/End | | Inspector |
|---|---|---|---|---|---|---|--|---|---|---|---|
| 4 | 0.78 | 0.78 | Earthen Levee | Encroachments | CR | PO | Buildings Inspector Comments: Embassy Suites | 38.579712 ° -121.507347 ° | 38.579712 ° -121.507347 ° | 4 Y | |

| Embassy Suites | |

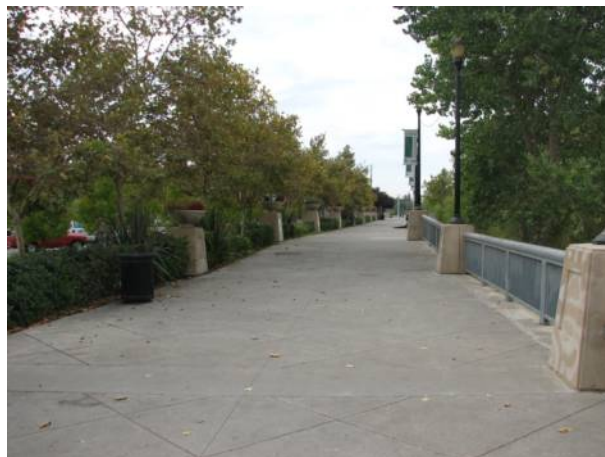
| Levee Mile Report Line | 5 |

| Waterway | | | | | | | Bank | Unit Miles | Inspection Start/End | | Inspector |
|---|---|---|---|---|---|---|--|---|---|---|---|
| 5 | 0.78 | 0.93 | Earthen Levee | Encroachments | CR | PO | Landscaping Inspector Comments: River walk along the water front | 38.579705 ° -121.507360 ° | 38.577740 ° -121.508147 ° | 5 Y | |

| River walk crown with landscaping | |

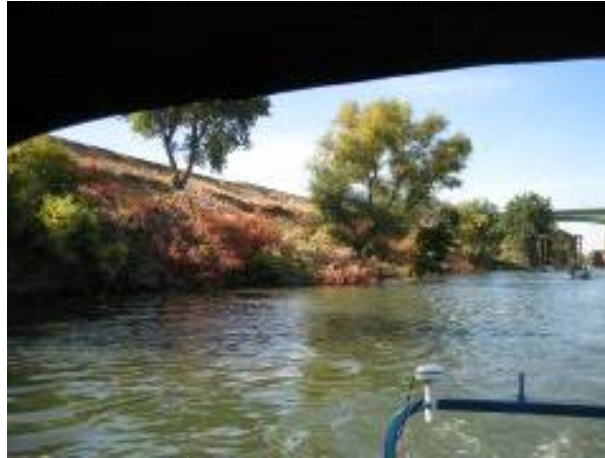
| Levee Mile Report Line | 6 |

| Waterway | | | | | | | Bank | Unit Miles | Inspection Start/End | | Inspector |
|---|---|---|---|---|---|---|--|---|---|---|---|
| 6 | 1.33 | 1.40 | Supplemental | USACE Erosion Survey | WS | M | Inspector Comments: 2009: no berm, 2:1 slope, holes, sands and silts, 4.81 ft/s [2009 SiteID:SAC_58-4_L] | 38.573133 ° -121.512278 ° | 38.572342 ° -121.513175 ° | 15 Y | |

| 2009: no berm, 2:1 slope, holes, sands and silts, 4.81 ft/s [2009 SiteID:SAC_58-4_L] | |

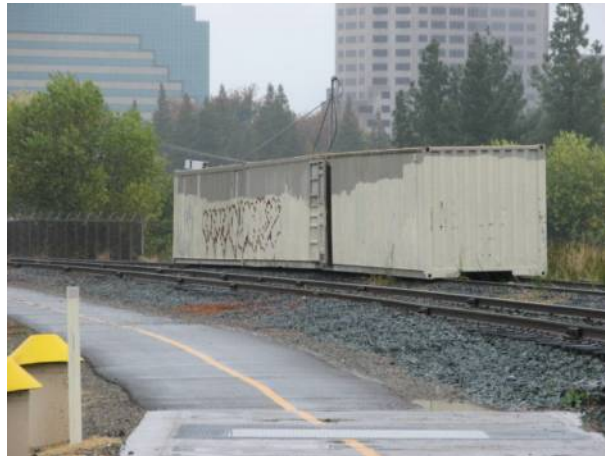
| Levee Mile Report Line | 7 |

| Waterway | | | | | | | Bank | Unit Miles | Inspection Start/End | | Inspector |
|---|---|---|---|---|---|---|--|---|---|---|---|
| 7 | 1.52 | 1.52 | Earthen Levee | Encroachments | CR | PO | Buildings | 38.572267 ° -121.512312 ° | 38.572267 ° -121.512312 ° | 11 Y | |

| Storage bins on tracks placed by Railroad Museum | |

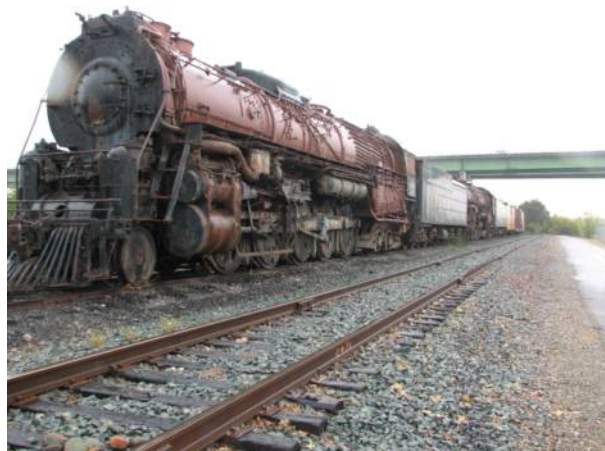
| Levee Mile Report Line | 8 |

| Waterway | | | | | | | Bank | Unit Miles | Inspection Start/End | | Inspector |
|---|---|---|---|---|---|---|--|---|---|---|---|
| 8 | 1.54 | 1.54 | Earthen Levee | Encroachments | CR | M | Equipment Inspector Comments: This area is a concern due to work the COE did at Pioneer Reservoir with a stability berm and monitoring wells on the land side. This is due to the levee seepage. The concern is that the weight of the train cars may cause problems. Total eight cars. | 38.571495 ° -121.513615 ° | 38.571495 ° -121.513615 ° | 12 Y | |

| Picture of most of the train cars City of Sacramento is concerned about the weight of the cars on the levee This area has a seepage problem | |

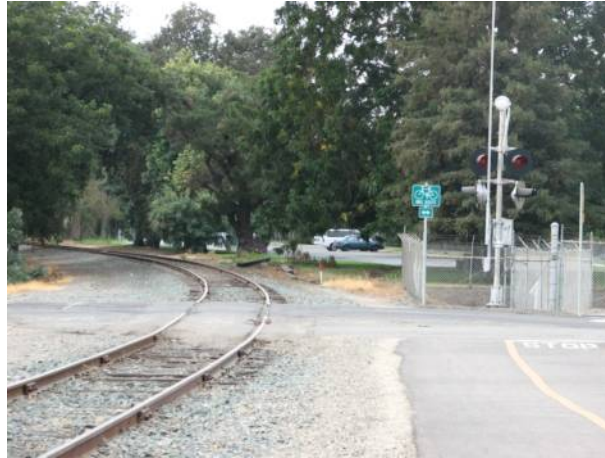
| Levee Mile Report Line | 9 |

| Waterway | | | | | | | Bank | Unit Miles | Inspection Start/End | | Inspector |
|---|---|---|---|---|---|---|--|---|---|---|---|
| 9 | 1.73 | 1.96 | Earthen Levee | Encroachments | CR | W | Equipment Inspector Comments: Levee is oversize with railroad tracks and paved parking this area is Miller Park | 38.568172 ° -121.516042 ° | 38.564882 ° -121.516265 ° | 6 Y | |

Miller Park at Broadway railroad track and parking area on levee

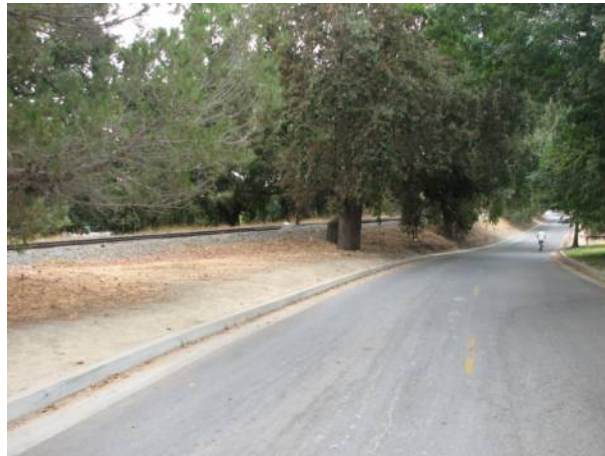
| Levee Mile Report Line | 10 |

| Waterway | | | | | | | Bank | Unit Miles | Inspection Start/End | | Inspector |
|---|---|---|---|---|---|---|--|---|---|---|---|
| 10 | 1.96 | 2.34 | Earthen Levee | Encroachments | CR | W | Equipment Inspector Comments: Railroad tracks run on crown of levee, paved roadway runs along toe on waterside this is Miller Park Marina area. | 38.564900 ° -121.516253 ° | 38.559460 ° -121.515085 ° | 7 Y | |

Railroad tracks on levee crown street to boat ramp

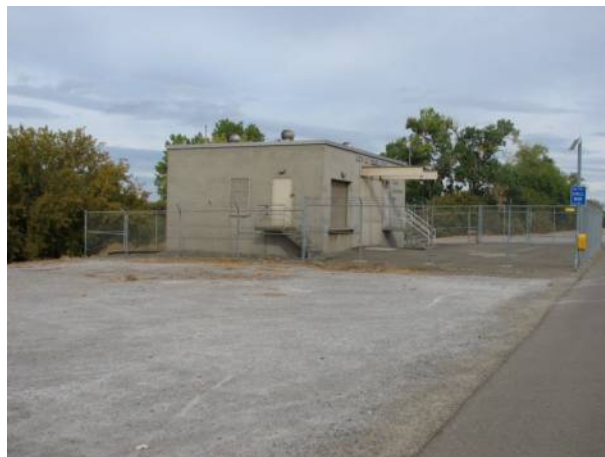
| Levee Mile Report Line | 14 |

| Waterway | | | | | | | Bank | Unit Miles | Inspection Start/End | | Inspector |
|---|---|---|---|---|---|---|--|---|---|---|---|
| 14 | 2.90 | 2.90 | Earthen Levee | Encroachments | CR | PO | Buildings | 38.551810 ° -121.511838 ° | 38.551810 ° -121.511838 ° | 10 Y | |

pump station city of Sacramento crown of levee waterside
